TREE PRESERVATION PLAN
SCALE = 1:250

RON KOUJDS LANDSCAPE ARCHITECTS INC.

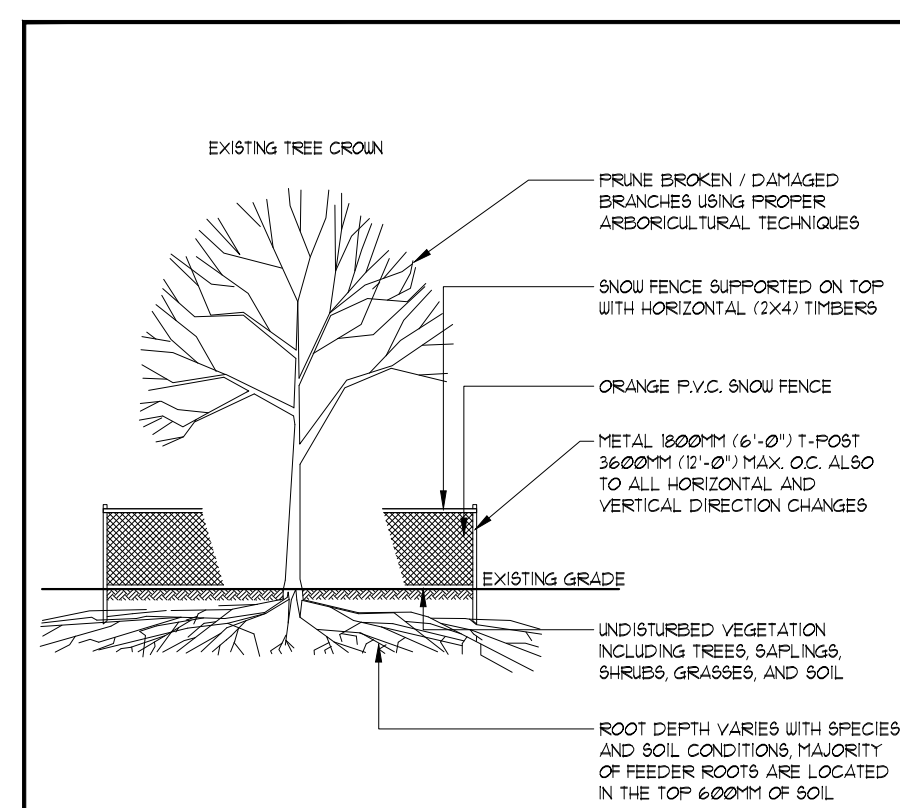
TEMP. TREE PROTECTION BARRIER - N.T.S.

- NOTES:**
- EXISTING TREES ARE TO BE PROTECTED FROM CONSTRUCTION WITH THE INSTALLATION OF A 2000MM (6'-0") HIGH SNOW FENCE HELD IN PLACE WITH 8000MM (6'-0") T-BARS.

- THE BARRIER IS TO BE INSTALLED PRIOR TO ANY CONSTRUCTION AND NOT REMAIN IN PLACE UNTIL ALL CONSTRUCTION IS COMPLETED.
 - ALL SUPPORTS AND BRACING SHOULD BE INSIDE THE TREE PROTECTION ZONE. ALL SUCH SUPPORTS SHOULD MINIMIZE DAMAGING ROOTS IN THE TREE PROTECTION ZONE.

- NO CONSTRUCTION ACTIVITY, GRADE CHANGES, SURFACE TREATMENT, OR EXCAVATION OF ANY KIND IS PERMITTED WITHIN THE TREE PROTECTION ZONE.
 - NO MOVEMENT OF EQUIPMENT, STORAGE OF BUILDING SUPPLIES, CLEANING OR EQUIPMENT, OR DRIPPING OF SOLVENTS, GASOLINE, ETC. THAT OCCUR WITHIN THIS FENCE LINE.

- WHERE HIGH QUALITY SPECIMENS OCCUR ADJACENT TO AREAS SUBJECTED TO INTENSIVE CONSTRUCTION ACTIVITY, WOODEN CRIBBING SHOULD BE INSTALLED TO PROTECT TRUNKS FROM DAMAGE IN THE EVENT THAT HEAVY EQUIPMENT BREAKS DOWN THE SNOW FENCING.

- FENCE TO BE INSPECTED BY ENVIRONMENTAL CONSULTANT ON A REGULAR BASIS AND BE MAINTAINED BY THE SUBCONTRACTOR / BUILDER.
